Libby VARQ Flood Control Impacts on Kootenay River Dikes

Hamish Weatherly, Hydrologist

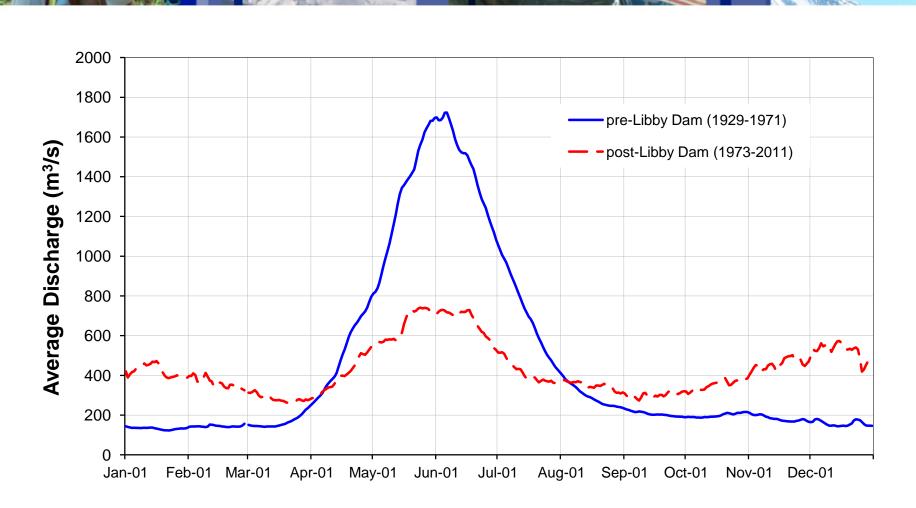
Porthill, Idaho

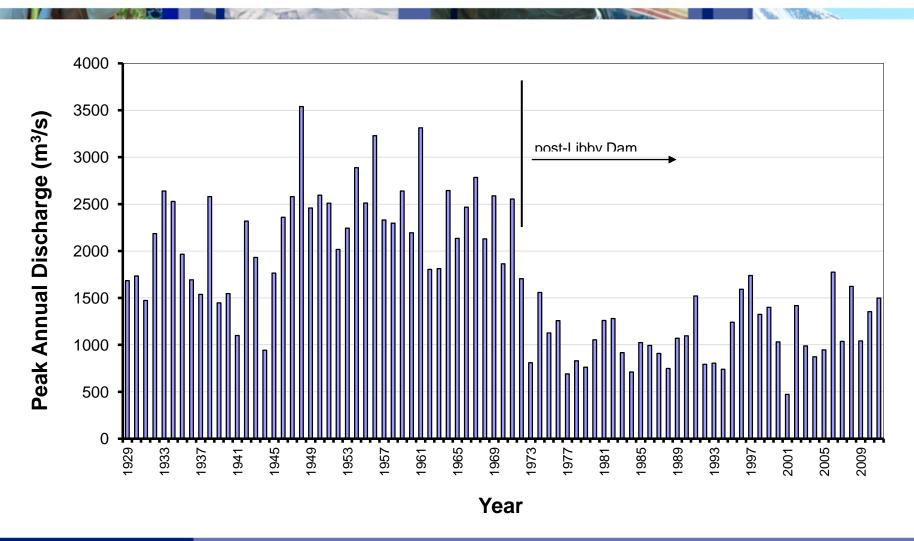
Kootenay River Peak Flows

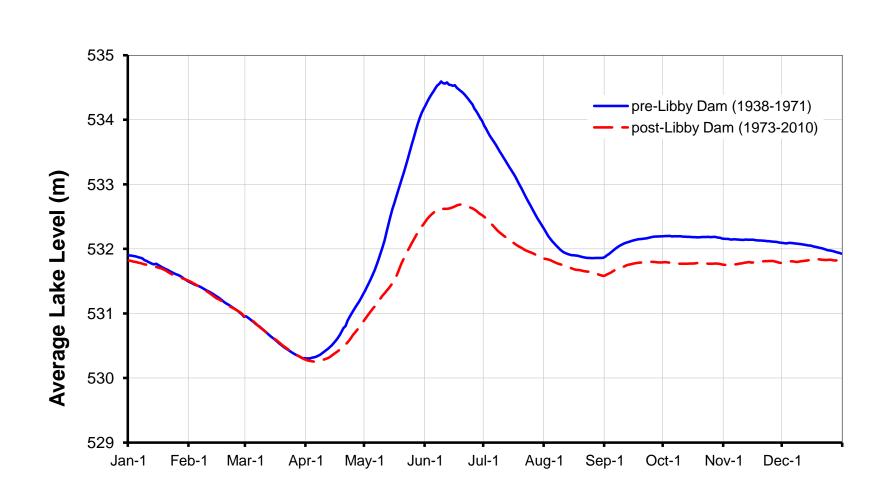
Kootenay Lake

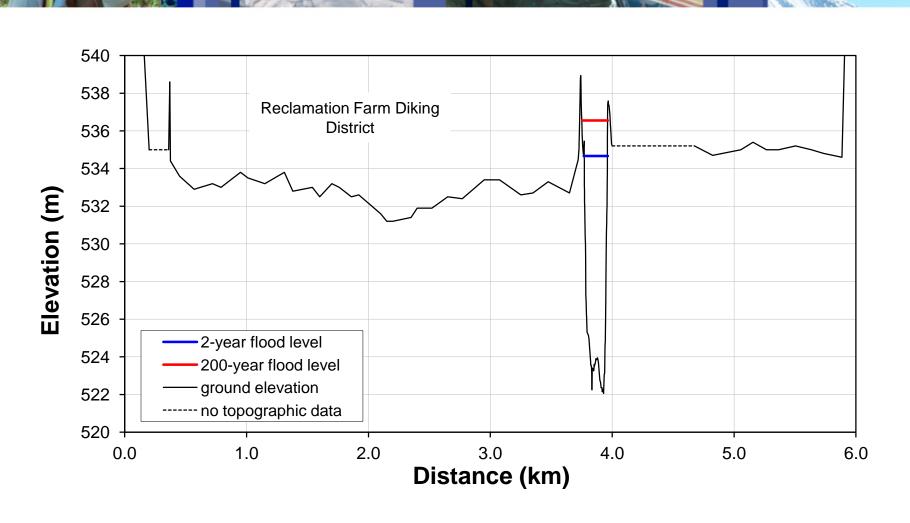
Kootenay River

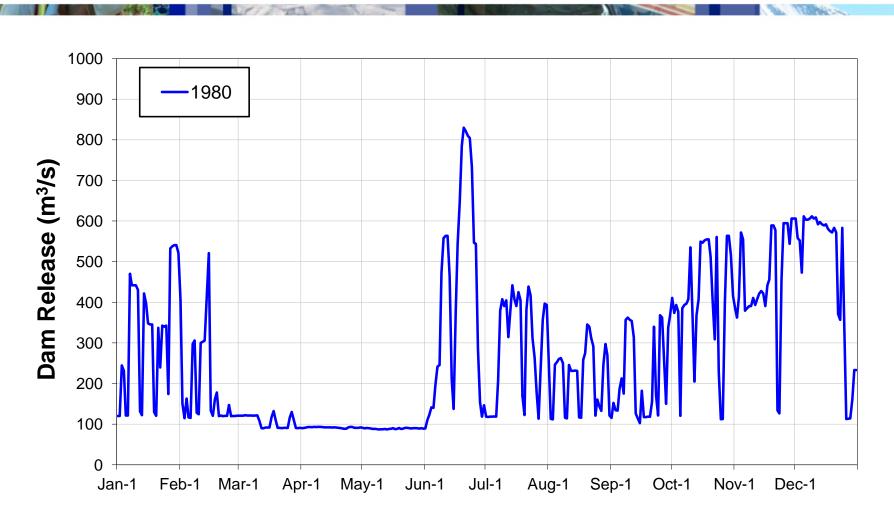
Load Following

- Prior to the late 1990's, Libby Dam was operated with the practice of load following
 - Refers to fluctuations in dam releases that correspond to changes in power demand
 - Load following was typically employed during the late fall and winter

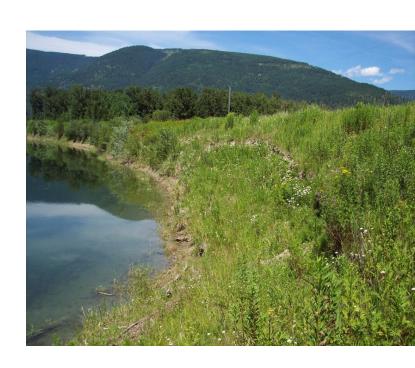
- The US Army Corps of Engineers (2006) have also concluded that past practices of load following contributed to the erosion of the toe slope of much of the levee system in the Kootenai Valley
- Lack of riparian vegetation is also likely a factor
- Maximum ramping rates were therefore prescribed in the late 1990s
 - implemented not only for fisheries but also to help minimize dike/levee erosion along the river

"It is considered probable that the development of this notch is more pronounced now that the river level is controlled by Libby Dam in comparison to pre-Libby Dam, when the river level fluctuated over a wider range and the short duration releases from Libby Dam did not occur. The more limited range of water levels, greater fluctuations in flows during the winter season, and more frequent cycles of wetting and drying appears to induce a weakening of the banks resulting in toppling of soil wedges."

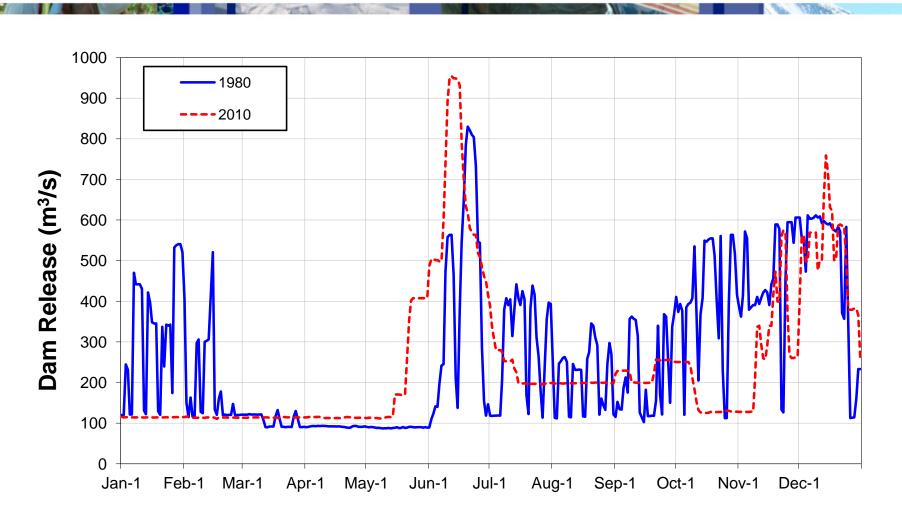
Prescribed Ramping Rates

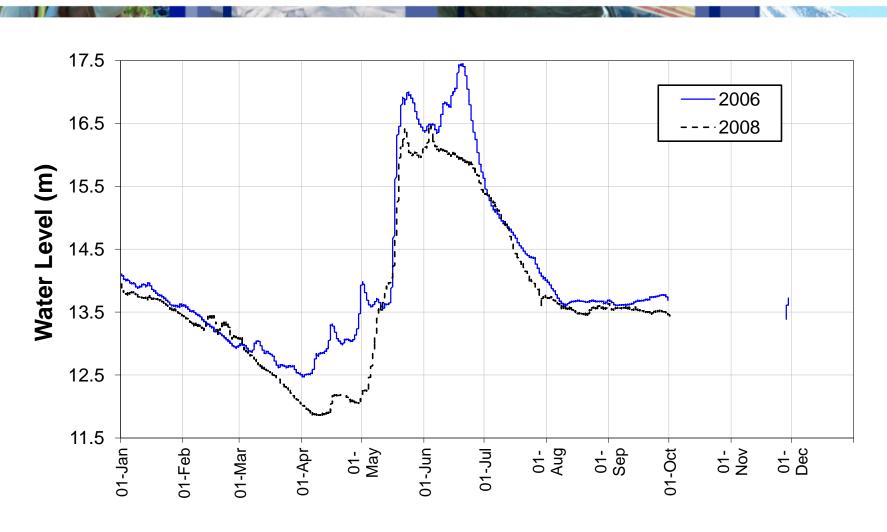
Load Following

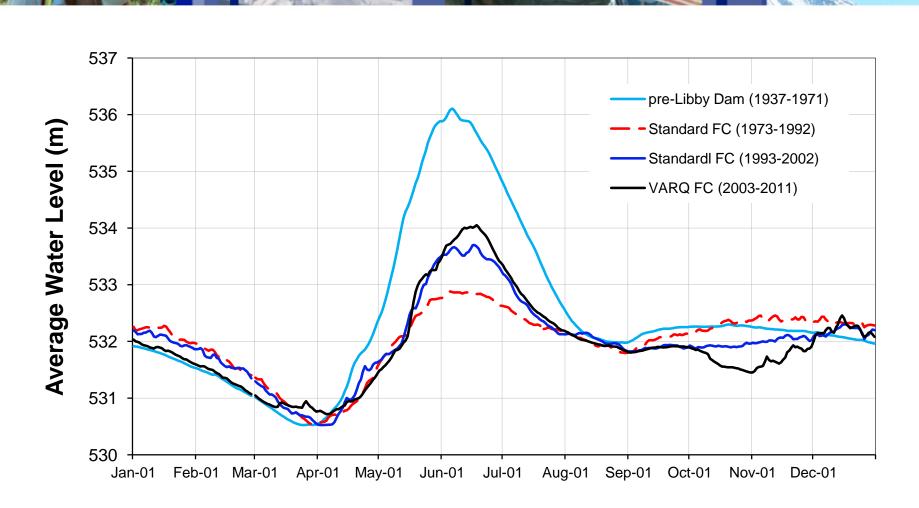
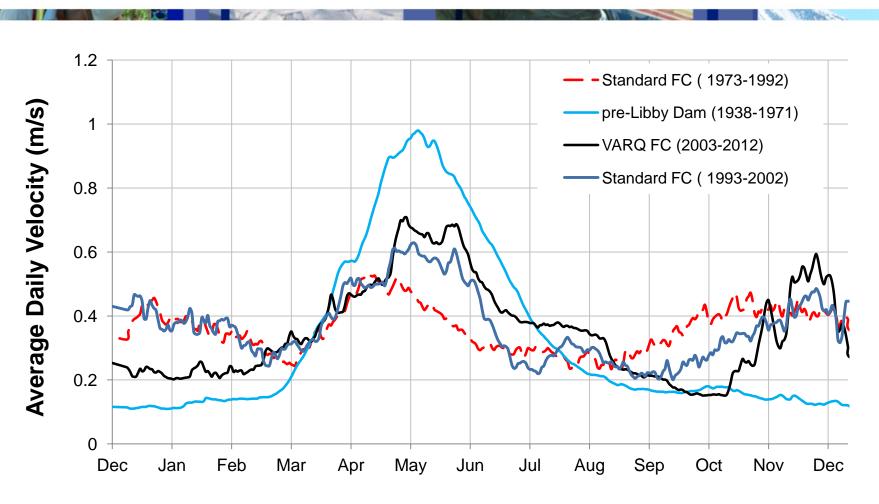
- Dam began discharging less water during the fall/winter period and more water during the spring/summer to benefit downstream fish.
- Standard and VARQ FC have the same storage space for flood control when then water supply forecast is 120% of normal
- In practice, there is only a difference in the two methods when the inflow forecast is between 80% and 120% of normal
