MINISTRY OF ENERGY, MINES AND NATURAL GAS

LIBBY VARQ FLOOD CONTROL IMPACTS ON KOOTENAY RIVER DIKES

PROJECT NO: 0640-002
DATE: November 7, 2012

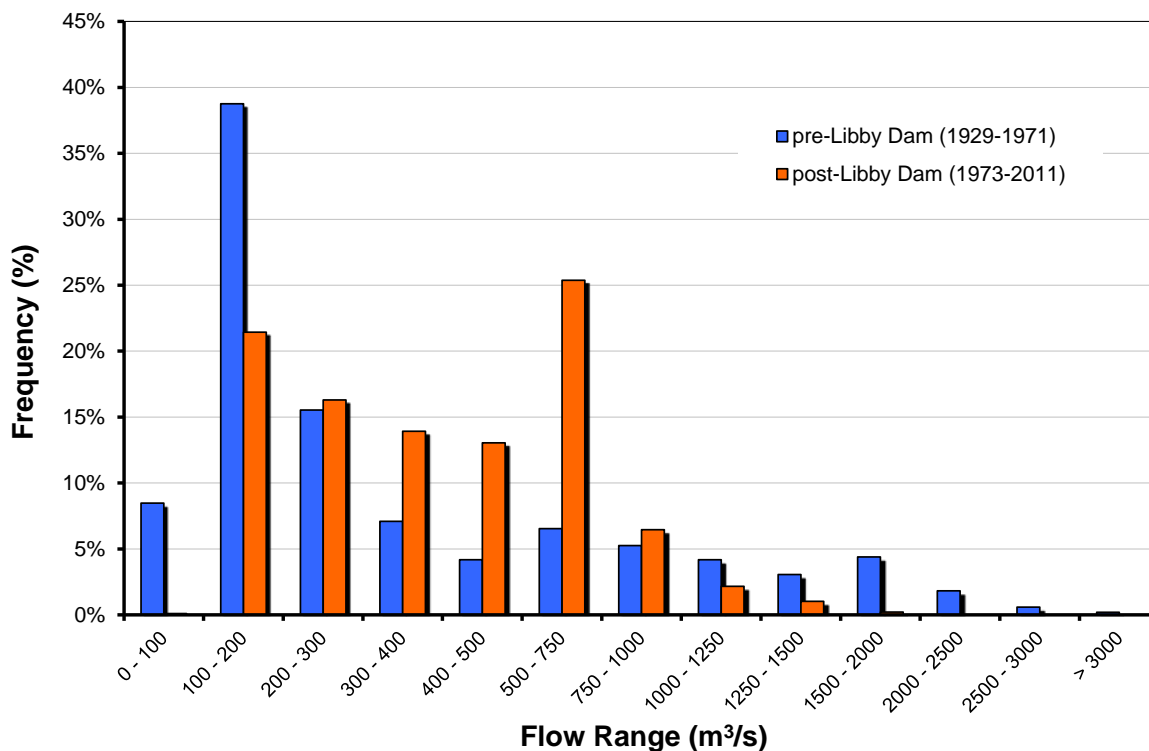
Figure 3-2. Histogram of Kootenay River Discharge at Porthill, Idaho

Both the pre- and post-Libby Dam duration curves indicate that for about 75% of the record, discharge remains below 650 m³/s. However, the tails of the two periods are significantly different. Prior to Libby Dam, Kootenay River flows were below 200 m³/s about 50% of the time, compared to 20% after dam construction. At the other end of the spectrum, flows used to exceed 1000 m³/s 14% of the time. Since dam construction, this percentage has reduced to 3%.

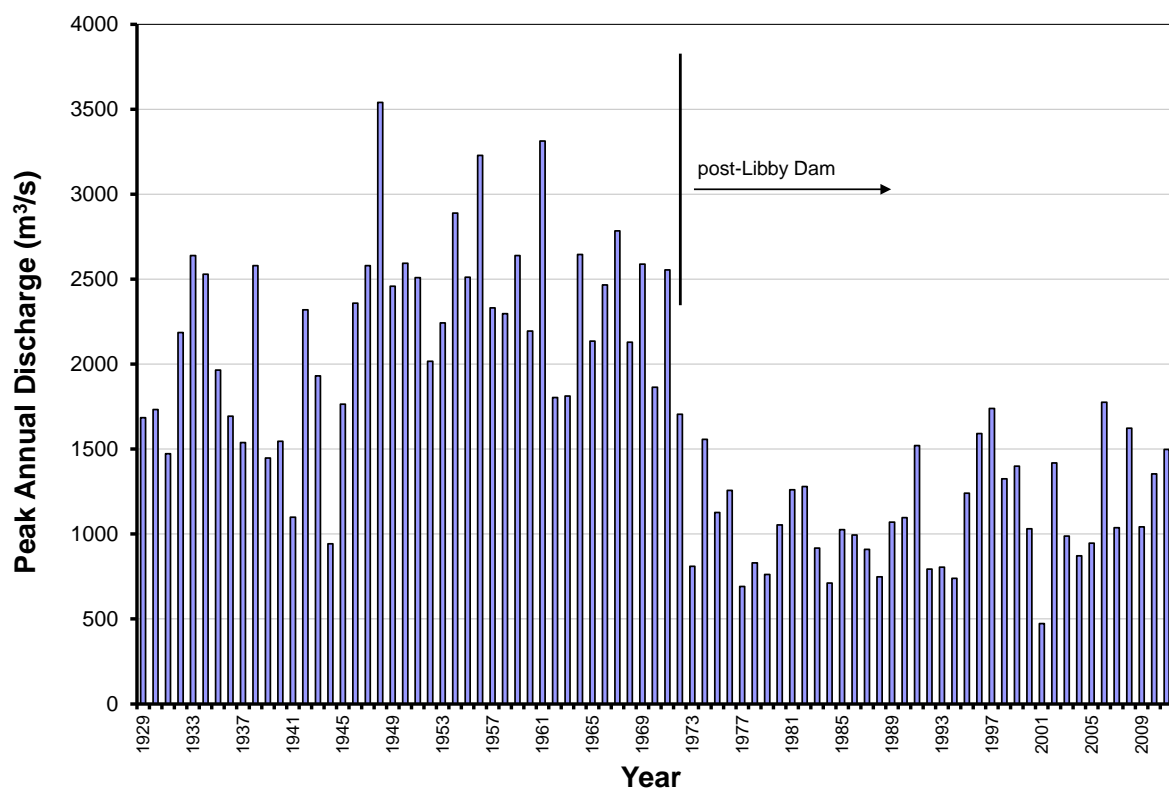
Figure 3-3. Annual Peak Flows on Kootenay River at Porthill, Idaho

The impact of flow regulation on peak flows is also illustrated by Figure 3-3, which plots peak annual flows at the Porthill gauge for the period 1929-2011. The significant impact of Libby Dam in reducing peak annual flows at Porthill is obvious on this figure.

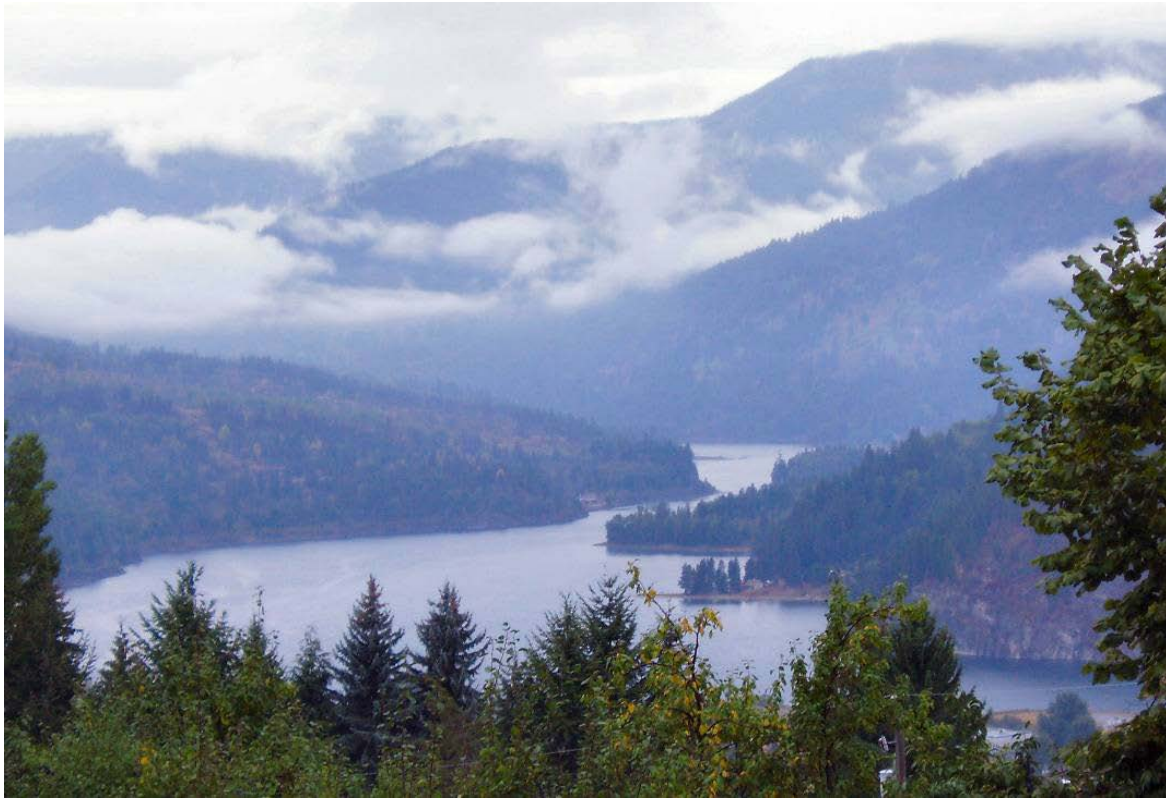
Figure 3-4. Upstream View of Grohman Narrows (IJC, 2007)

Grohman Narrows was a natural constriction of the West Arm of Kootenay Lake and is located about 10 km upstream of Corra Linn Dam (Figure 3-4). The feature is named after William Adolph Baillie-Grohman who, late in the 19th century, attempted to deepen the narrows in an early (and unsuccessful) effort to reclaim the farmlands of the Creston Valley and Kootenai Flats in the US. The narrows remained intact until the West Kootenay Power and Light Company dredged the constriction as a condition of the International Joint Commission's 1938 Order for Kootenay Lake. The Order stipulated that at least 250,000 yd³ of rock, gravel and boulders were to be removed from Grohman Narrows and at least 14,000 yd³ of a rock bluff jutting into the narrows on the south side. Excavation of Grohman Narrows reportedly lowered potential flood levels on Kootenay Lake by about 1 m. To this day, during the rising limb of the spring freshet and, normally, until after the peak annual level has occurred, water levels in Kootenay Lake continue to be controlled by the Narrows.

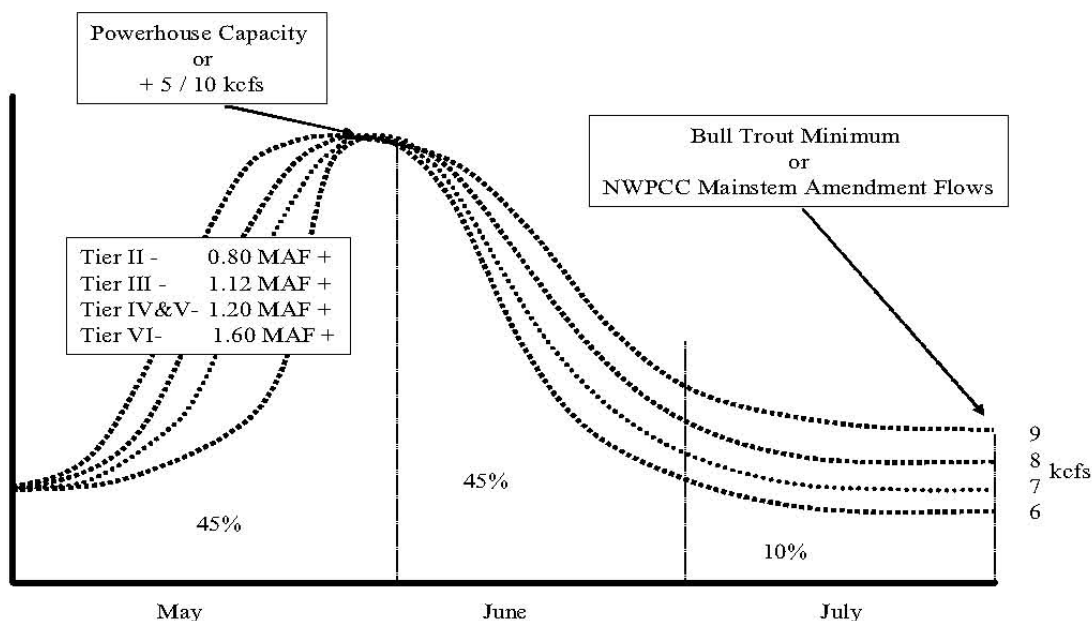
Figure 3-7. Schematic of USFWS (2006) Recommended Spring Freshet Hydrograph from Libby Dam (not to scale)

The remaining volume will be shaped over June (45%) and July (10%), targeting a final ramp down to reach minimum bull trout tiered flows by July 15. Higher tier years will have a more gradual ramp-down from powerhouse capacity, while lower tier years will have a more pronounced rise in May towards a peak. The post-peak augmentation flows are for the benefit of sturgeon incubation and rearing. Figure 3-7 is a schematic of the recommended Libby Dam release hydrograph during the freshet. Sturgeon augmentation flows would be curtailed if required for downstream flood control purposes.

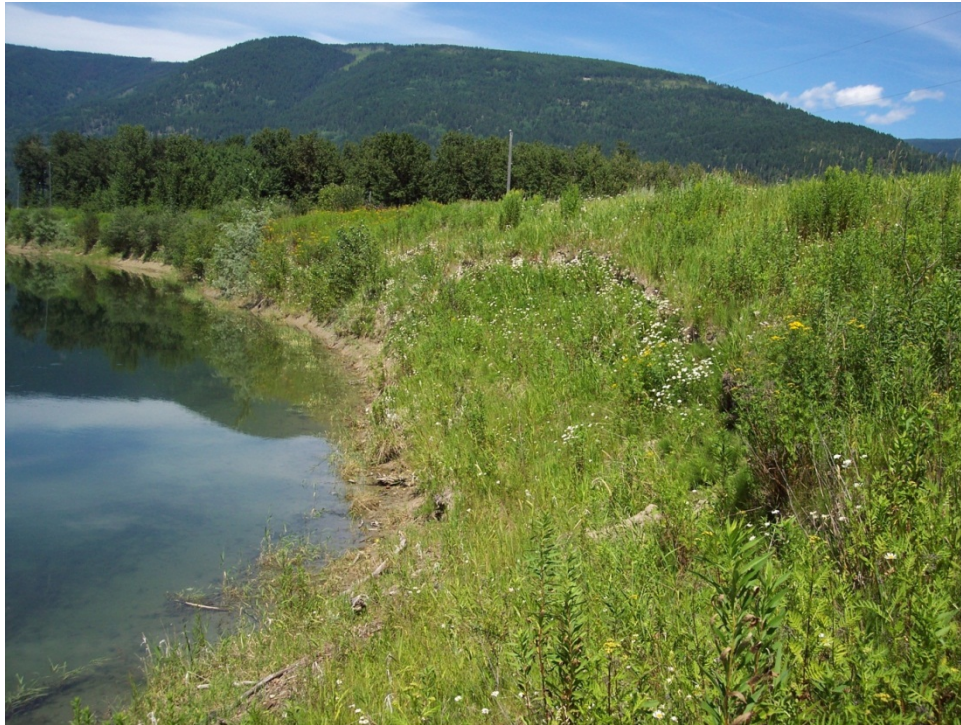
Scour at bends can have an important impact by bank stability by undercutting and oversteepening the toe of the bank (Photo 4-1). NHC (1999) compared Ministry of Environment surveys of 1968 and 1997, and observed that there had been no change in the deep scour holes along the river. It was therefore concluded that the overall stability of the underwater slopes has probably not changed substantially since Libby Dam regulation commenced.

Photo 4-1. Bank instability at outside of meander bend adjacent to IR5 (2005). Photo courtesy of Dwain Boyer, Ministry of Environment.

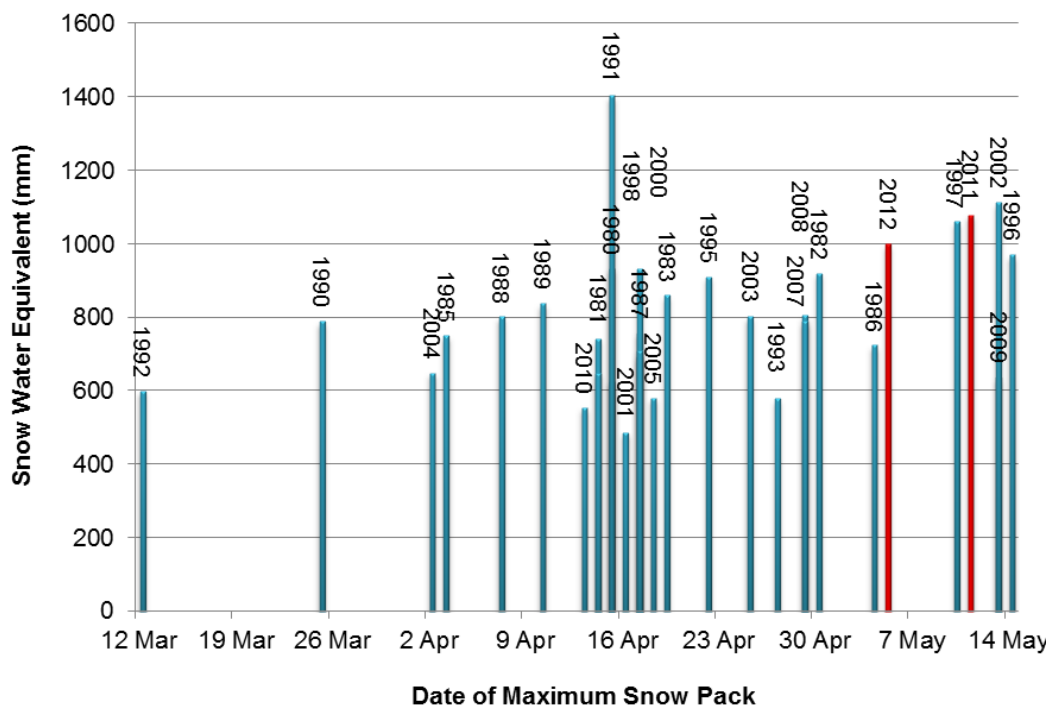
A review of all historical snow packs on record reveals that the 2011 and 2012 snow packs were some of the largest on record and had the latest freshet. Figure 6-5 and Figure 6-6 illustrate the peak snowpack date and water equivalent for stations 2C10P and 2C09Q, respectively.

Figure 6-5. Peak snowpack day and water equivalent depth for all recorded years from station 2C10P. 2011 and 2012 are highlighted on the graph.

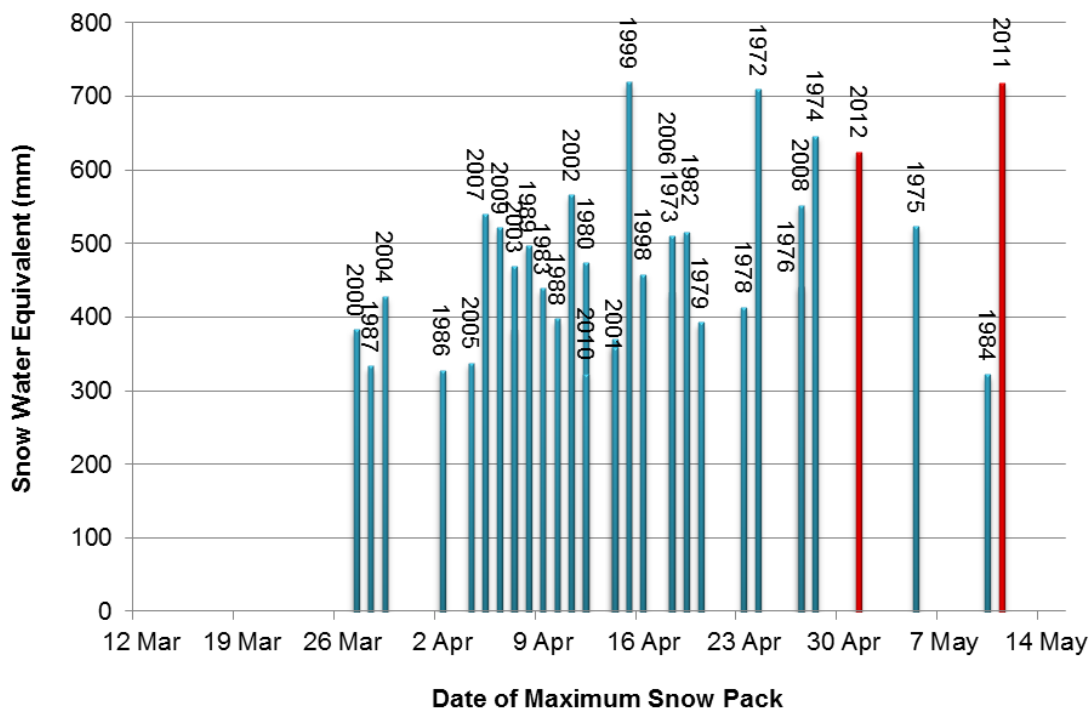
Figure 6-6. Peak snowpack day and water equivalent depth for all recorded years from station 2C09Q. 2011 and 2012 are highlighted on the graph.
