Kinbasket Reservoir Revegetation Program

Kinbasket Revegetation

Kinbasket Revegetation Early Implementation

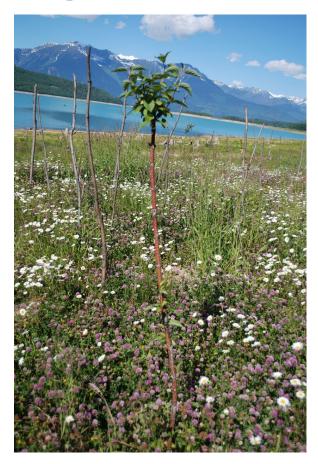
July 2010

Low survivorship of planting trials

- 75 hectares treated from 2008 –
 2013 with sedges and live stakes
- o In 2009, 194,000 sedges were planted over 19 ha

- Less than 5% survival four years post treatment
- 2014 Revegetation Technical Forum recommended smaller scale targeted pilots of debris mounds and debris exclusion booms for key wetland areas

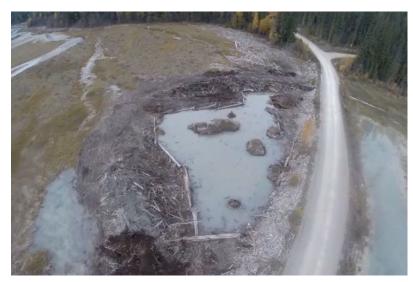
October 2015

Aerial view of wetlands and mounds – Bush Arm

- Targeted wetland with significant debris accumulation
- Mounding in 2015 and planting in 2016
- Initial establishment was mixed success depending on micro-site
- 2020 surcharge provided test conditions for wind/wave action on structural integrity
- Some loss of function but still monitoring resilience over next few years

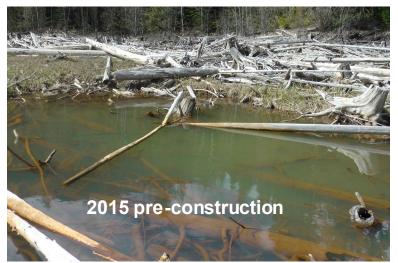
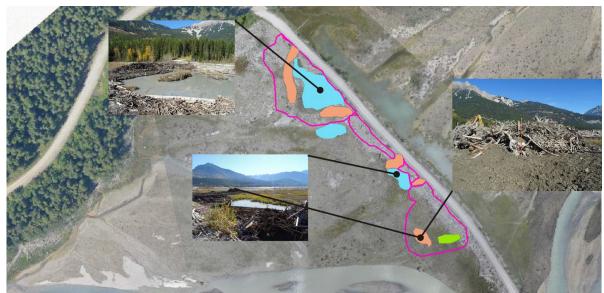
Bush Arm Mounds 2015

Mound construction utilized local wood debris cleared from area

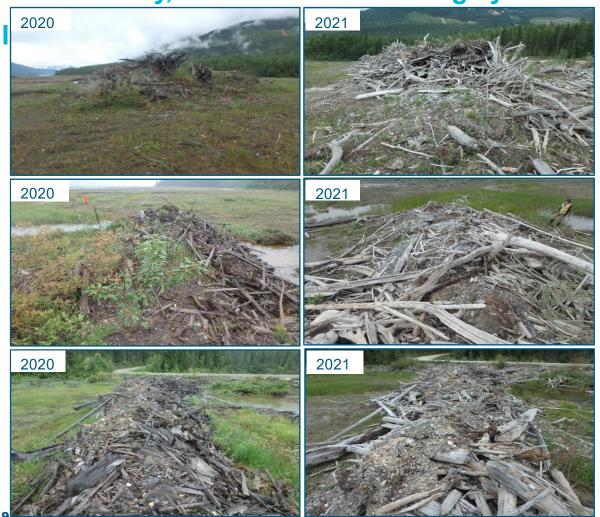
Pre and post 2020 monitoring Kinbasket Revegetation Debris mounds

Structurally, mounds remained largely intact

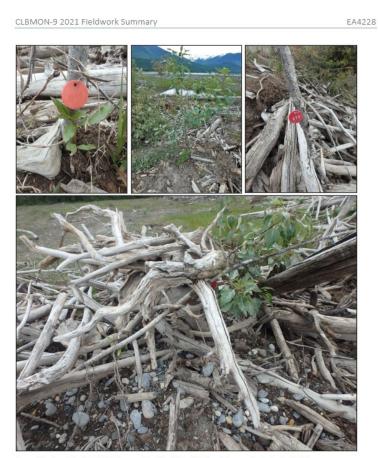
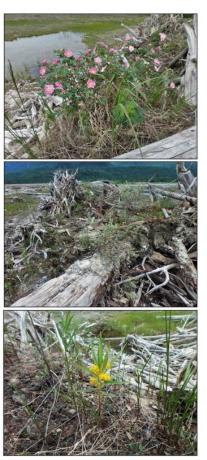
2021 Post-surcharge debris mounds

Some revegetation has persisted on the mound tops
